Office of the West Virginia Attorney General

Elk River Chemical Spill INCIDENT REPORT

January 8, 2015

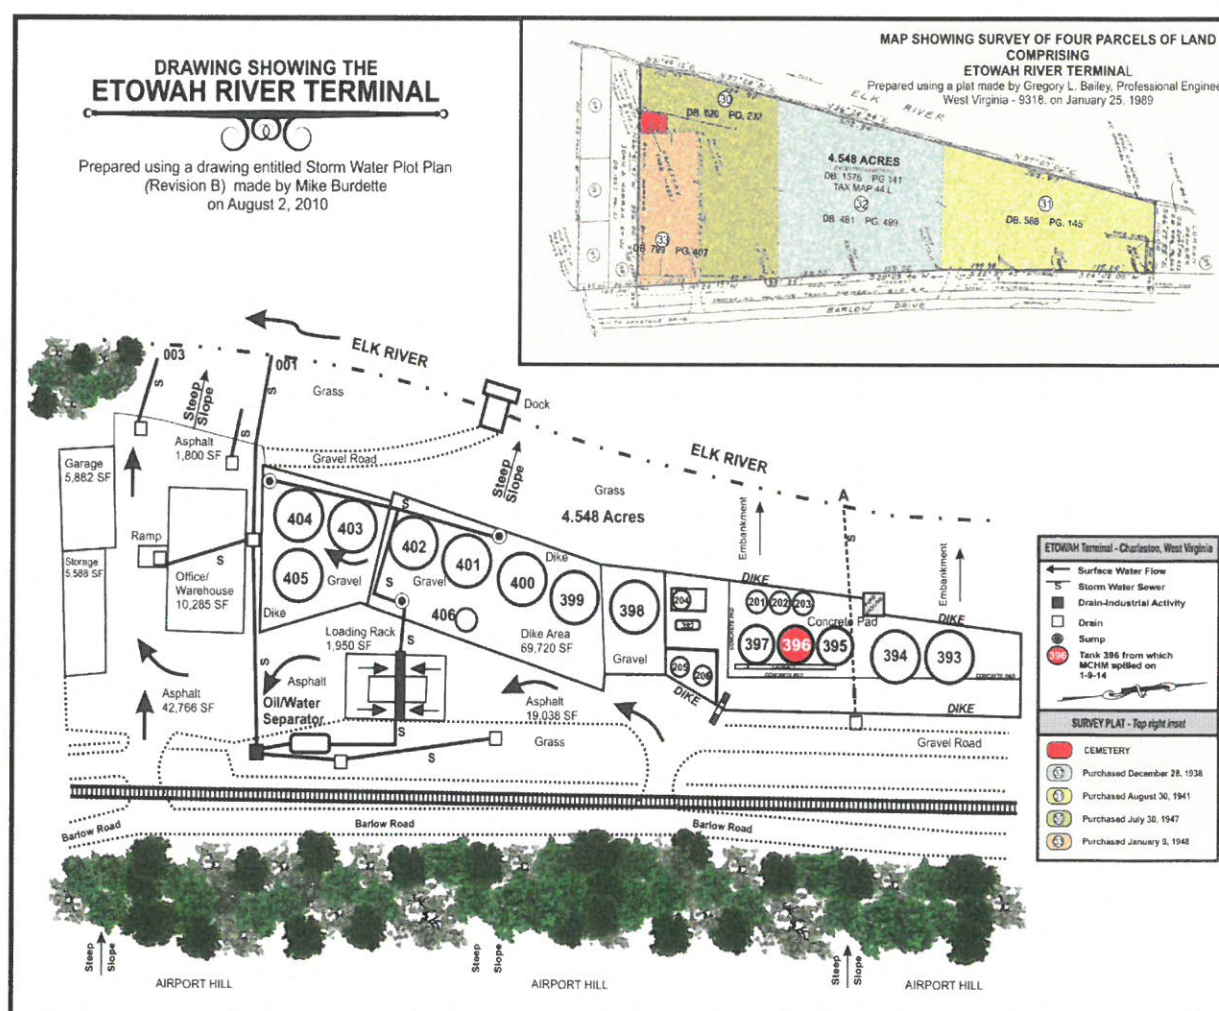
As reflected in the figure below, the tanks are surrounded by a containment wall (a.k.a. dike) around the tanks. The containment wall was found to have been divided by four (4) such structures:

- the first or southernmost dike surrounded tanks 403, 404, 405;
- the second dike surrounded tanks 399, 400, 401, and 402;
- the third dike surrounded tank 398;
- the fourth dike surrounded tanks 201, 202, 203, 204, 205, 206, 392, 393, 394, 395, 396, and 397.

The containment walls were constructed of brick or cinderblock, and were generally topped or covered with concrete.

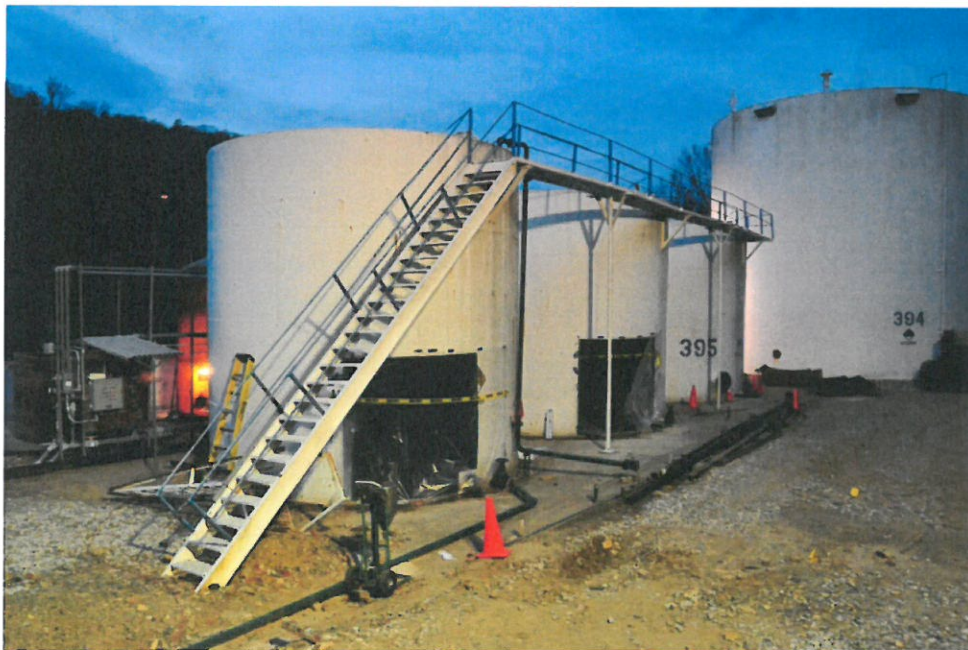
In addition to the containment wall, some of the ASTs were surrounded by concrete pads.

The concrete pads, however, did not extend underneath the ASTs. Instead, there was gravel or rock underneath each AST.

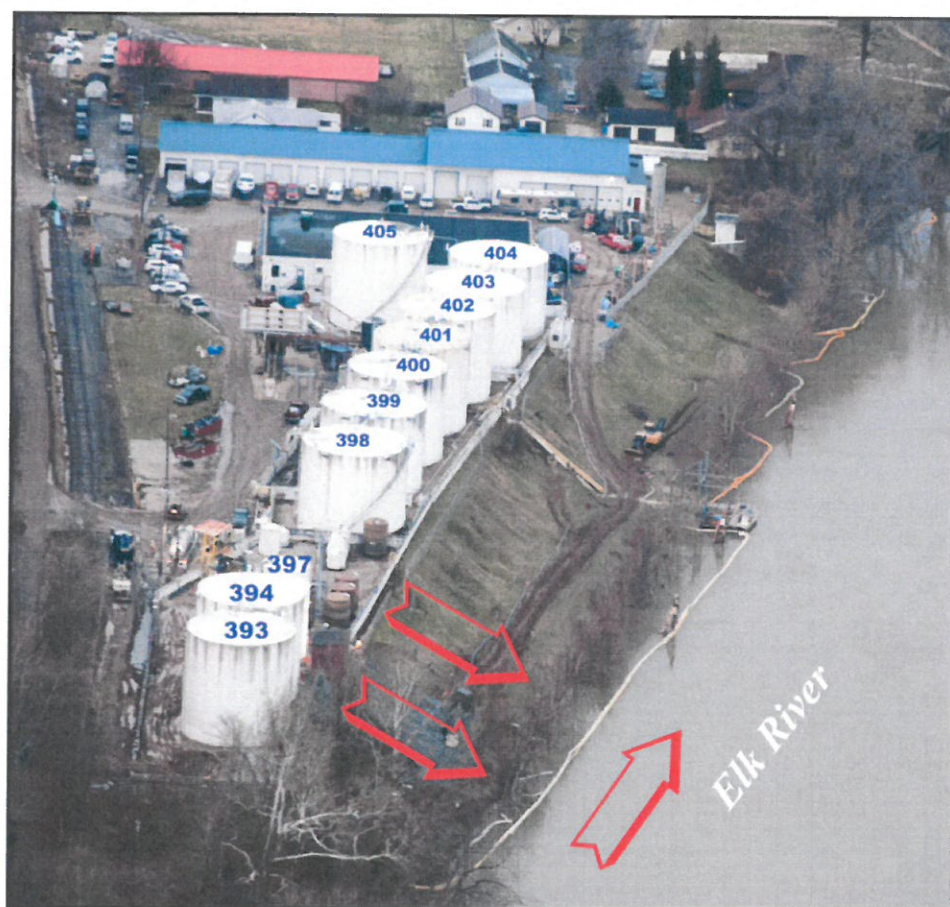
The WVAGO investigation revealed and documented the source of the chemical leak

at Freedom, the path through and under the containment wall, and the subsequent release into the Elk River.

In particular, the investigation revealed that chemicals escaped from tank 396 and tank 397, then flowed northwest to the containment wall in front of tanks 393 and 394.

The chemicals then leaked through and under the containment wall into the rubble-filled ground leading to the Elk River. The chemicals also traveled through a corroded culvert and/or pathways created by water leaking from the culvert. This culvert ran between tanks 395 and 394 and over the embankment to the river. There were thus at least two entry points in which chemicals were able to flow directly into the Elk River. The source and resultant contamination are detailed more fully below.

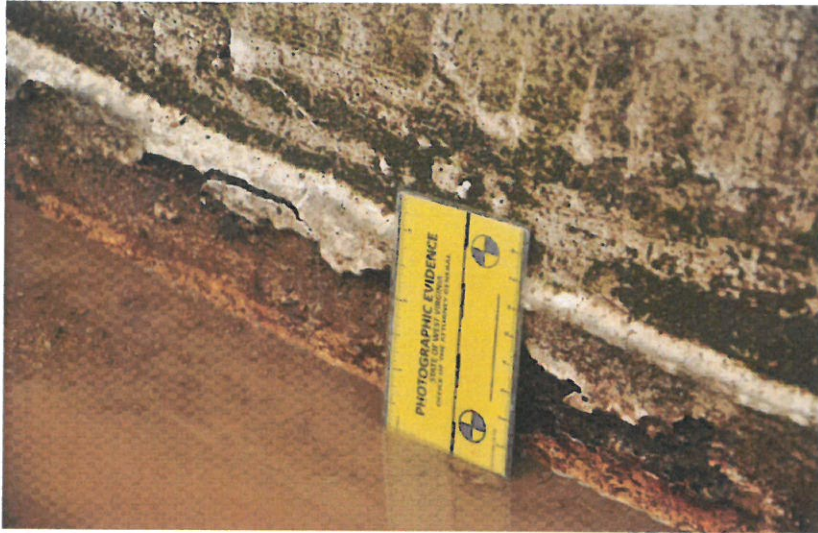
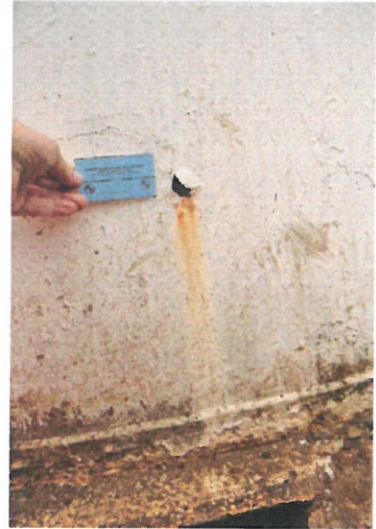
7.2.1 Deterioration and Neglect of Tank 396

Tank 396 was one of three aboveground storage tanks originally constructed by Elk Refining Company in 1938. A visual inspection of the tank showed its age, and

clearly reflected minimal upkeep of the tank. Despite significant documentation and reports regarding other larger tanks, little documentation or inspection reports were produced by Freedom relating to the maintenance or inspections of tank 396.

During the course of the investigation, the WVAGO photographed and documented the physical appearance of tank 396 and surrounding tanks. As reflected, in the photographs, the outside of tank 396 had flaking paint, rusting, and pitting. In addition, an inspection of the inside of the tank revealed neglect. First, the roof of the tank was leaking.
